Manhole Inspection Summary

Manhole # S35MM_017MH

Location Address: **2115 CALVERT ST**

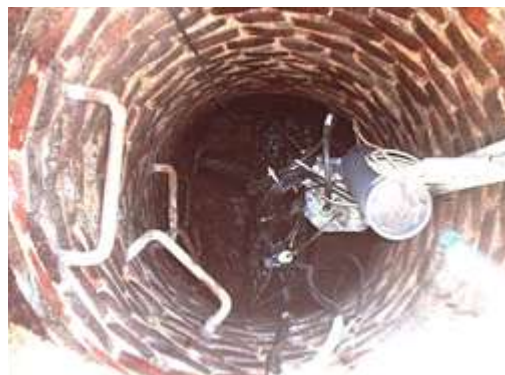
Top View

Bench debris.

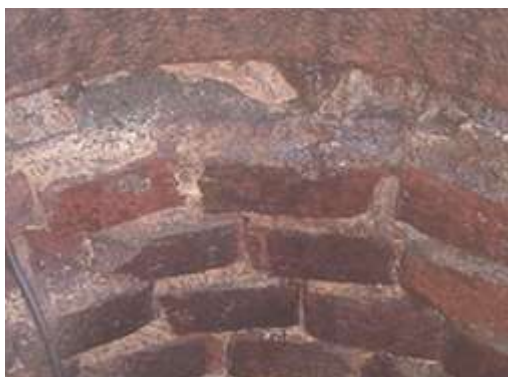
Defect

Frame leaks. Adjustment deterioration and infiltration.

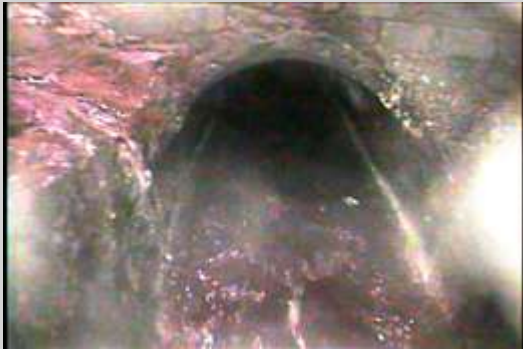
18 in. Circular Gravity Sewer Pipe Out @ 12 O'Clock

Deposits: ☐ None ☐ Mud ☐ Sludge ☐ Debris ☒ Grease

Silt Depth: **0** (in.) Deposits Extent: **Light**

Infiltration: **None** Pipe Seal Cond: **Cracked**

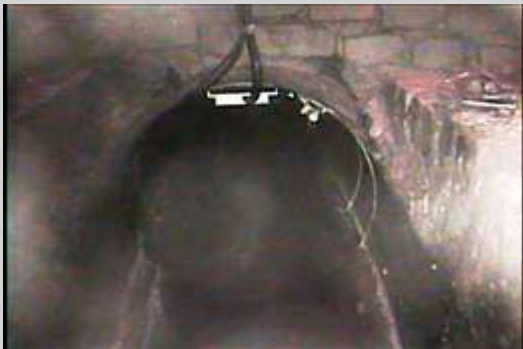
18 in. Circular Gravity Sewer Pipe In @ 6 O'Clock

Deposits: ☐ None ☐ Mud ☐ Sludge ☐ Debris ☒ Grease

Silt Depth: **0** (in.) Deposits Extent: **Light**

Infiltration: **Evidence** Pipe Seal Cond: **Cracked**

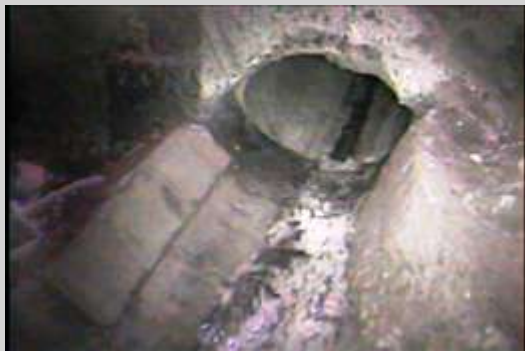
8 in. Circular Gravity Sewer
Pipe In @ 9 O'Clock

Infiltration: **Evidence** Pipe Seal Cond: **Unknown**
